Loud Clicking Noise from Right Side of the Printer

If the customer is experiencing a very loud clicking noise from the right side of the printer and the printer has less than 1,000 pages, it is possible that a developer gear became dislodged during the shipment of the printer. (Please note that a quiet clicking noise is normal. The quiet click noise occurs as the printer moves toner from the cartridge to the developer. This is part of the printer's normal operation).

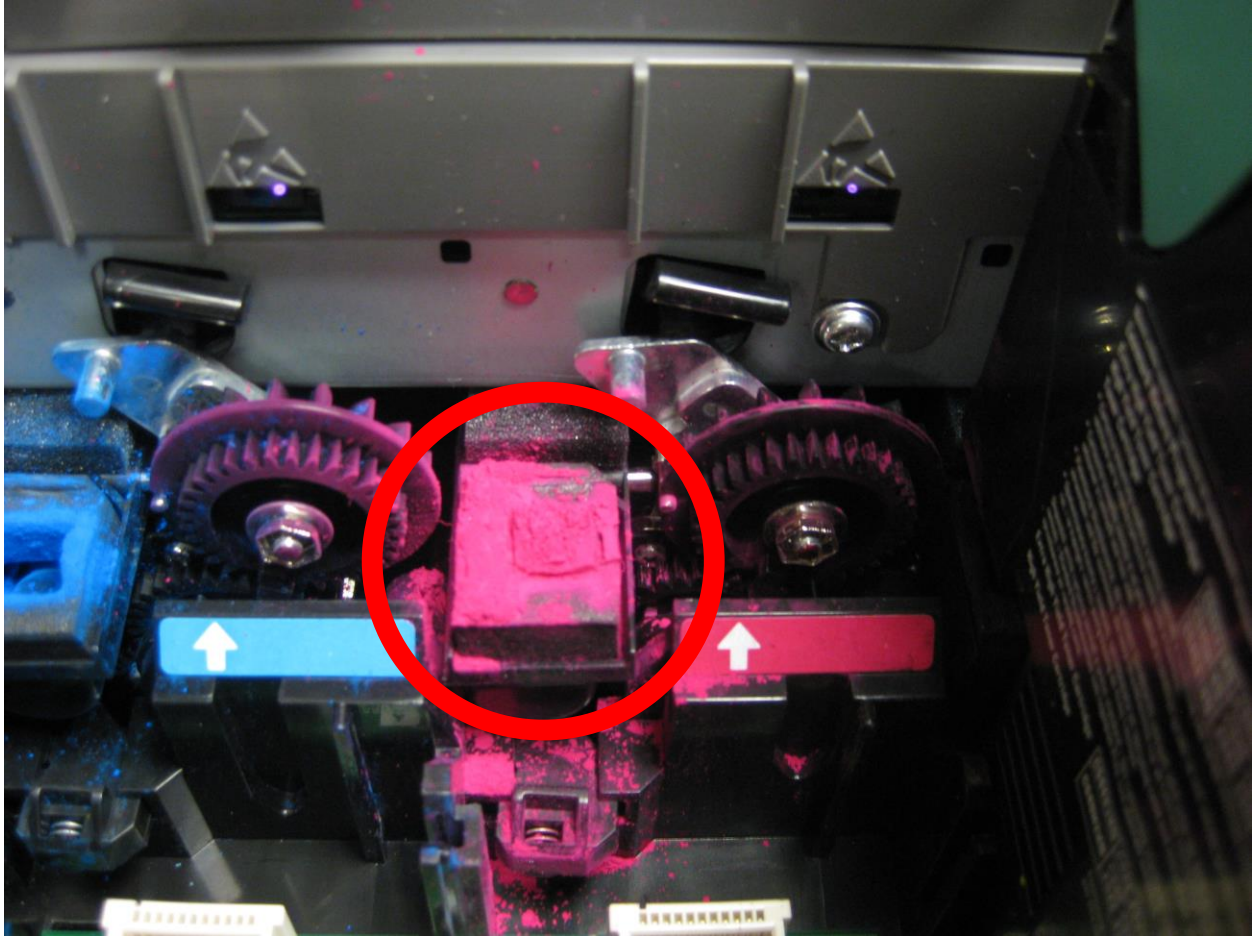
In the picture above, the magenta developer port is full of toner. This indicates that the developer gear may be dislodged. Inspect the developer ports for each color.

4) To fix this issue, remove the image basket. The following instructions will assist you in this process.

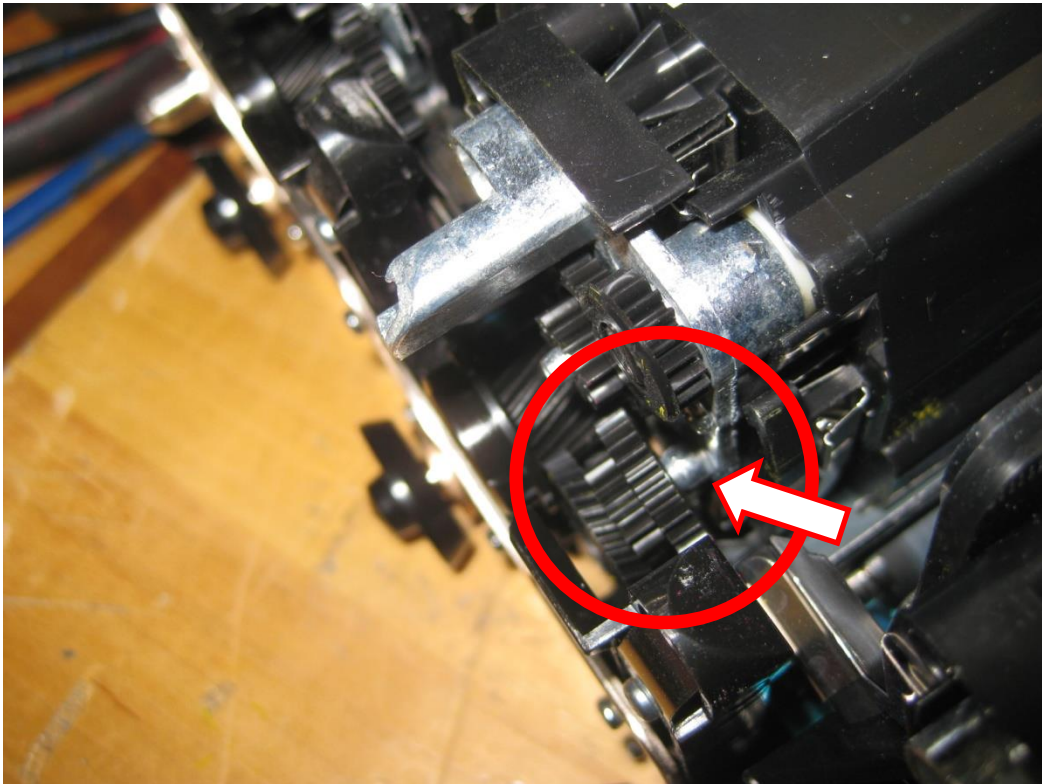
The picture above shows that the developer gear is disengaged. You can visibly see the metal shaft behind the gear and the gear is at an angle. The good news is that there is an easy fix for this!

- 6) To correct this problem, simply push the gear back, and it will reposition itself. It will now function properly. As this issue was caused by an impact during the shipment of this product, this issue should not happen again once the gear is properly repositioned. Please see the illustration below. Repeat this step for each color (CMYK).
